GPL'S FIELD SERVICE PROGRAM

BY CHRISTOPHER W. CLOSS
GPL Field Services Advisor

Chimneys Punctuate the Urban Skyline

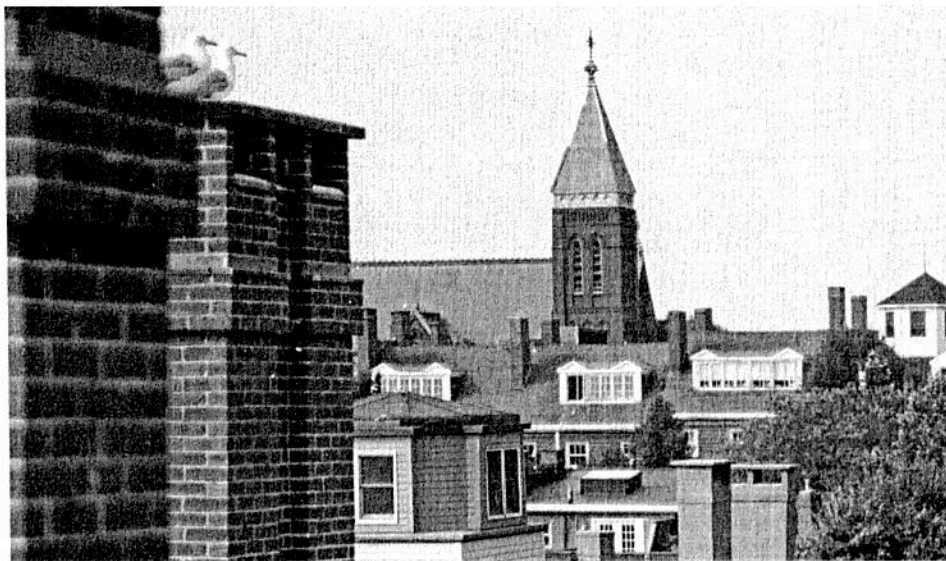
GPL restored the Safford House chimneys (left) to last another 100 years.

At its Safford House (1858) headquarters acquired in 2009, Greater Portland Landmarks inherited over 100 years of deferred maintenance hidden within the roof structure, belvedere, and chimney stacks. To preserve the historic appearance of the building, which is located on a prominent corner, GPL reconstructed

the five original chimneys. Each was thoroughly documented and dismantled to roof level. Upper shafts were replicated, including seismic-retrofitting, with internal epoxy-coated, vertical steel reinforcing bars, and then

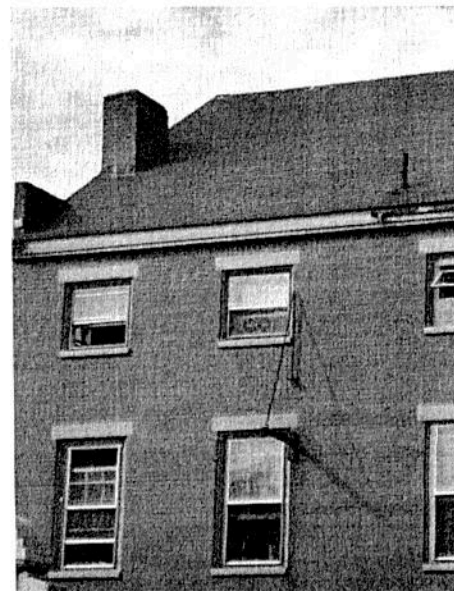
The upper portion of this chimney was partially removed, then capped.
